## **APPENDIX A**

### **Airport Background Information**

### **Community and Airport Background**

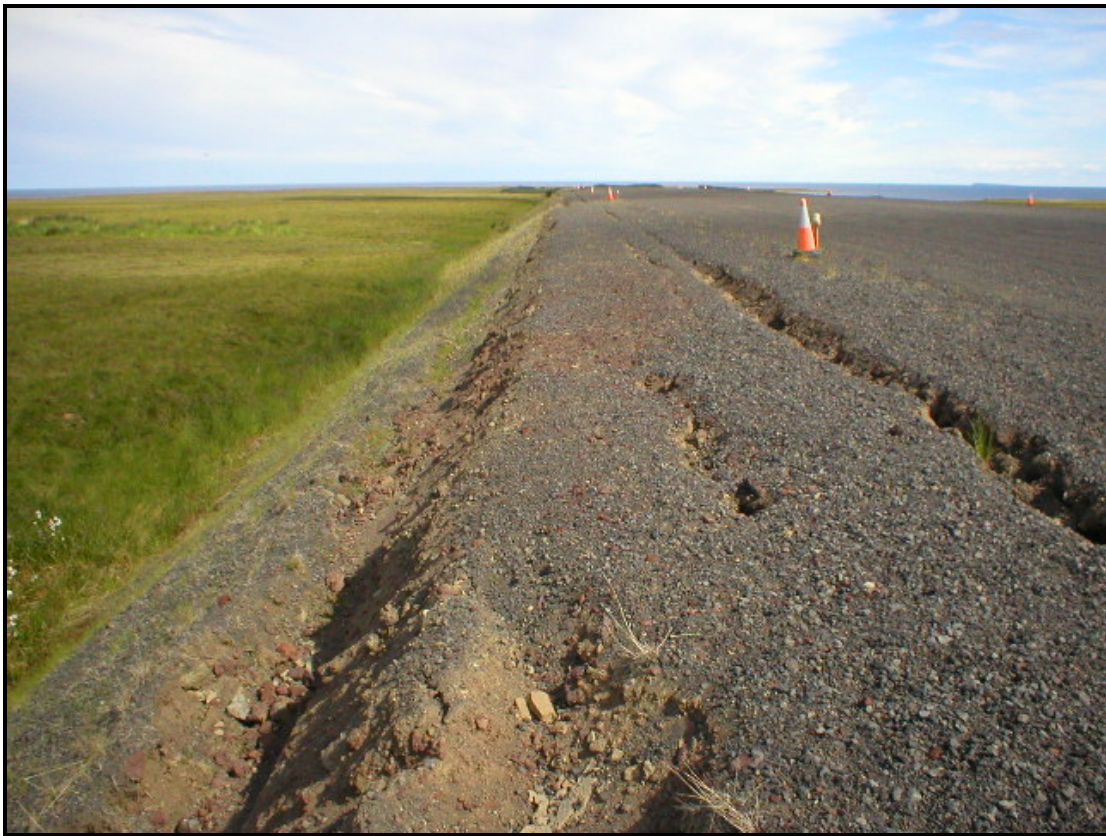
- The existing runway surface is depleted and damaged due to differential settlement at the shoulder resulting from permafrost degradation beneath the embankment. This settlement has caused large longitudinal and transverse cracks in the runway. Although no scientific evidence demonstrates it, DOT&PF experience suggest that shallower slopes do reduce permafrost degradation. In addition, shallower slopes will improve stability of the slope and provide safer conditions for airport users.

**Photograph A-1:  
Longitudinal Cracks on Runway Embankment caused by Permafrost Degradation**
