Subject: Sitka Seaplane Base

Determination of Eligibility Recommendation: Japonski Island Observation Post (SIT-01115) Sitka, Alaska

January 2021

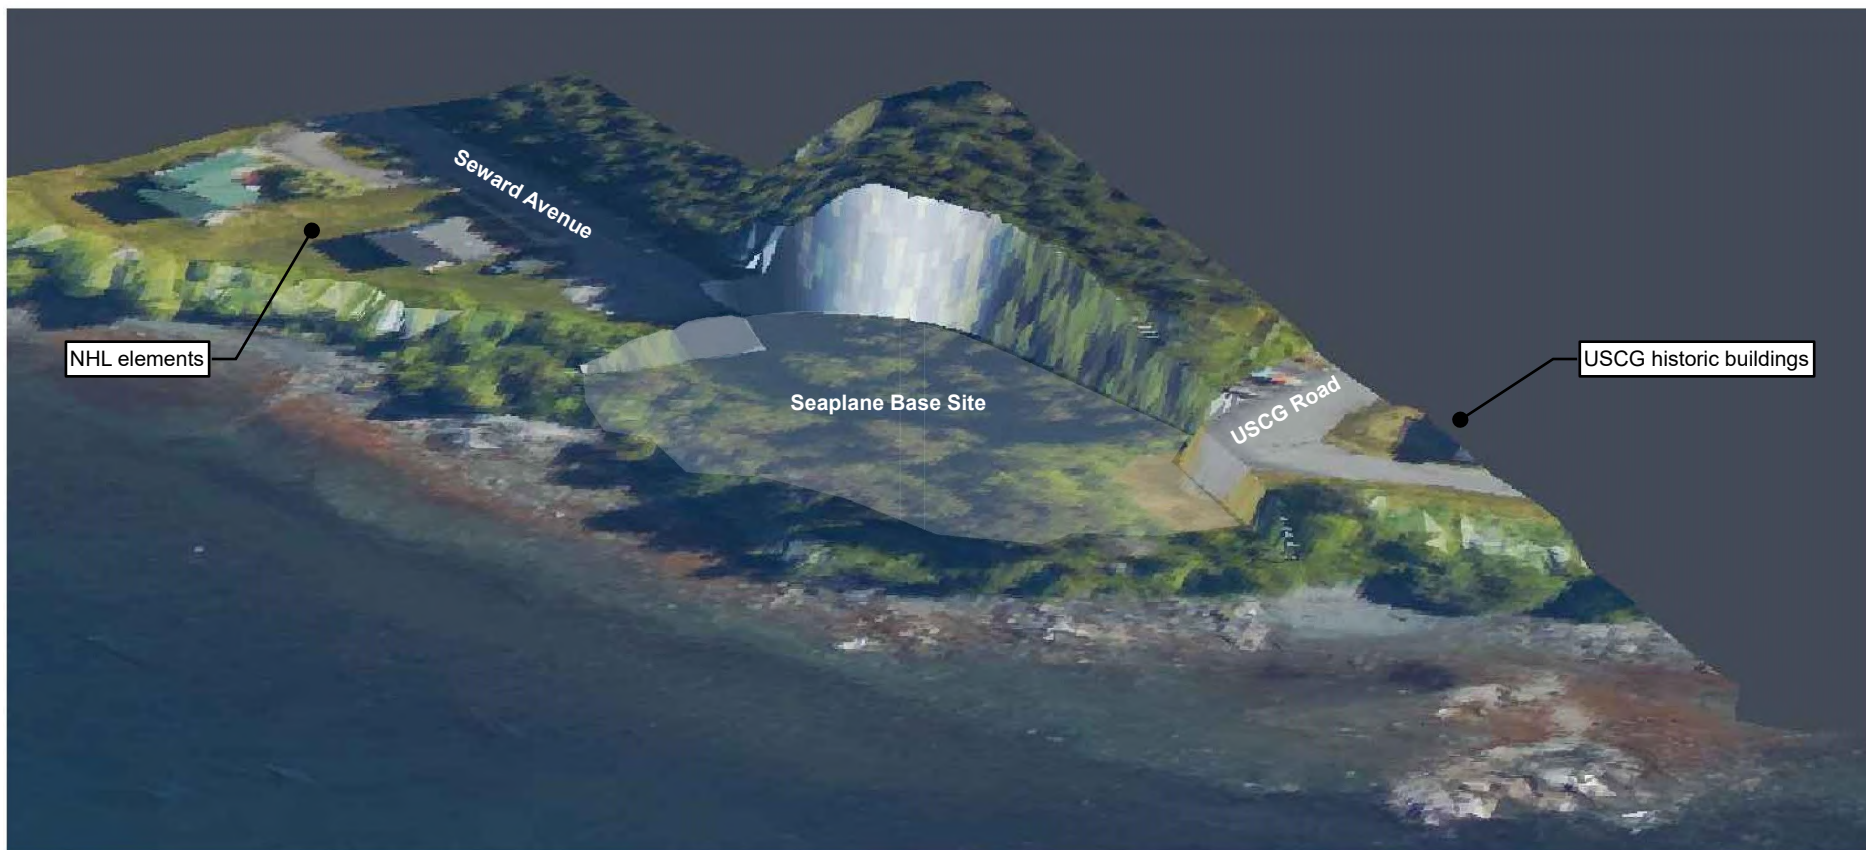
Rock Cut Topographic Rendering

Note: This rendering is a visual representation of the elevation differences between the proposed project finished site and other historic structures/areas. The image is not to scale and may not accurately show distances between various structures/features.

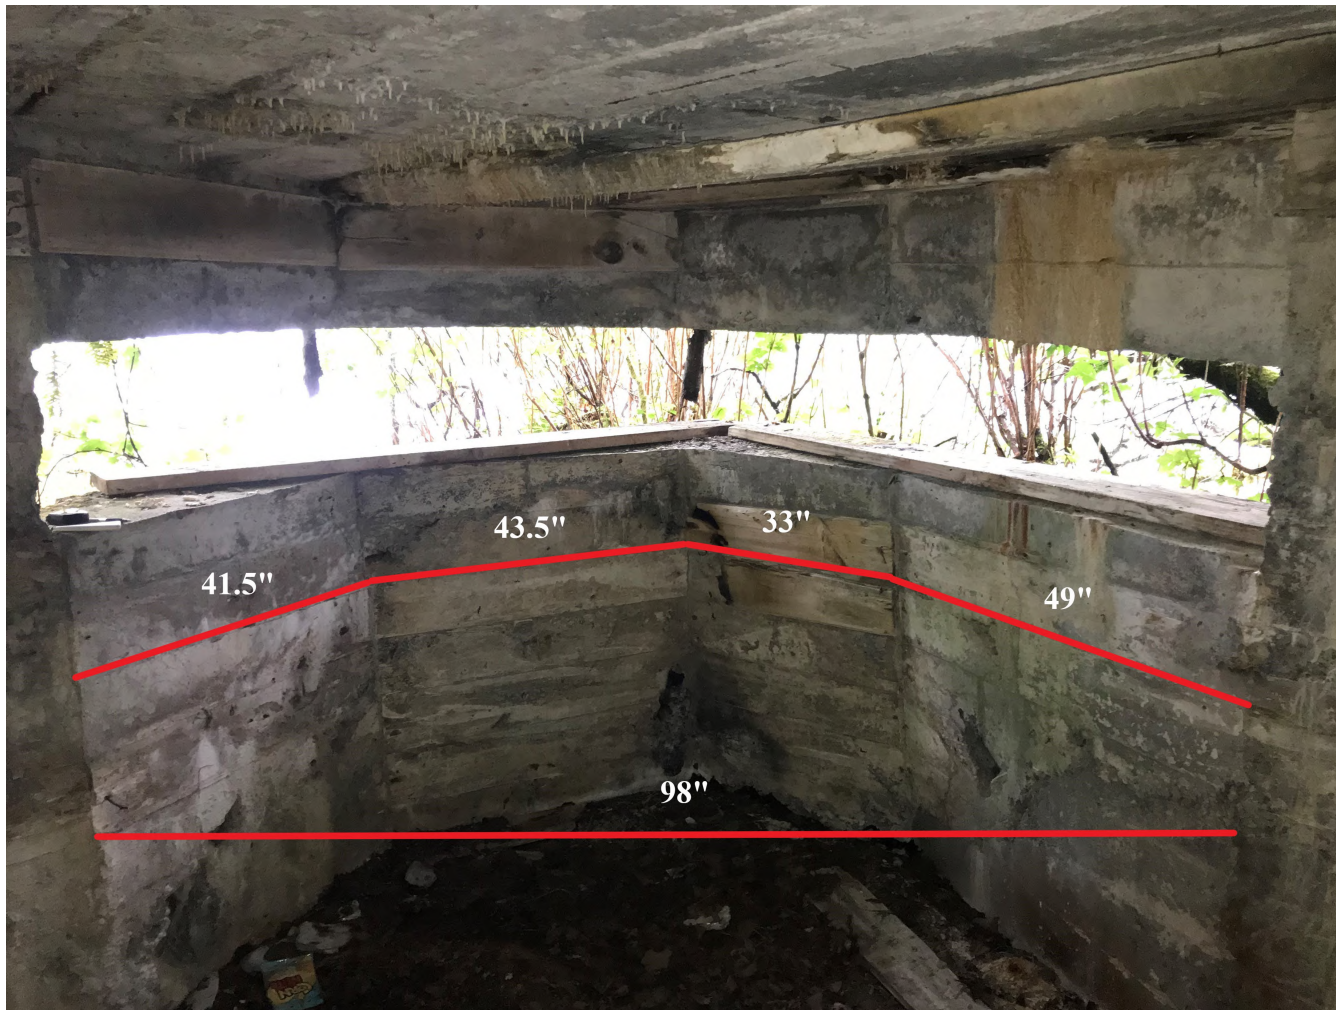
Observation Slit Dimensions

SIT-01115 consists of a concrete building within the APE and is overall rectangular in shape with a slightly off-center observation slit situated on the north wall (Figure 6). There is a single entrance (Figure 7). The observation slit, which is roughly 16" in height, offers 180-degree views of Sitka Channel. At one time the observation slit had three upright metal supports. The walls range in thickness from approximately 12" to 20". The interior dimensions are irregular due to the observation slit and measure roughly 8.667ft (104") by 13.25ft (159"), or 115 square feet. Approximate interior dimensions are depicted in Figure 8. There are wooden boards set high on the interior walls and along the observation slit. Construction also included some earthworks, evidenced by a collapsed covered trench on the south side, and stone reinforcements on the north (Figure 9).

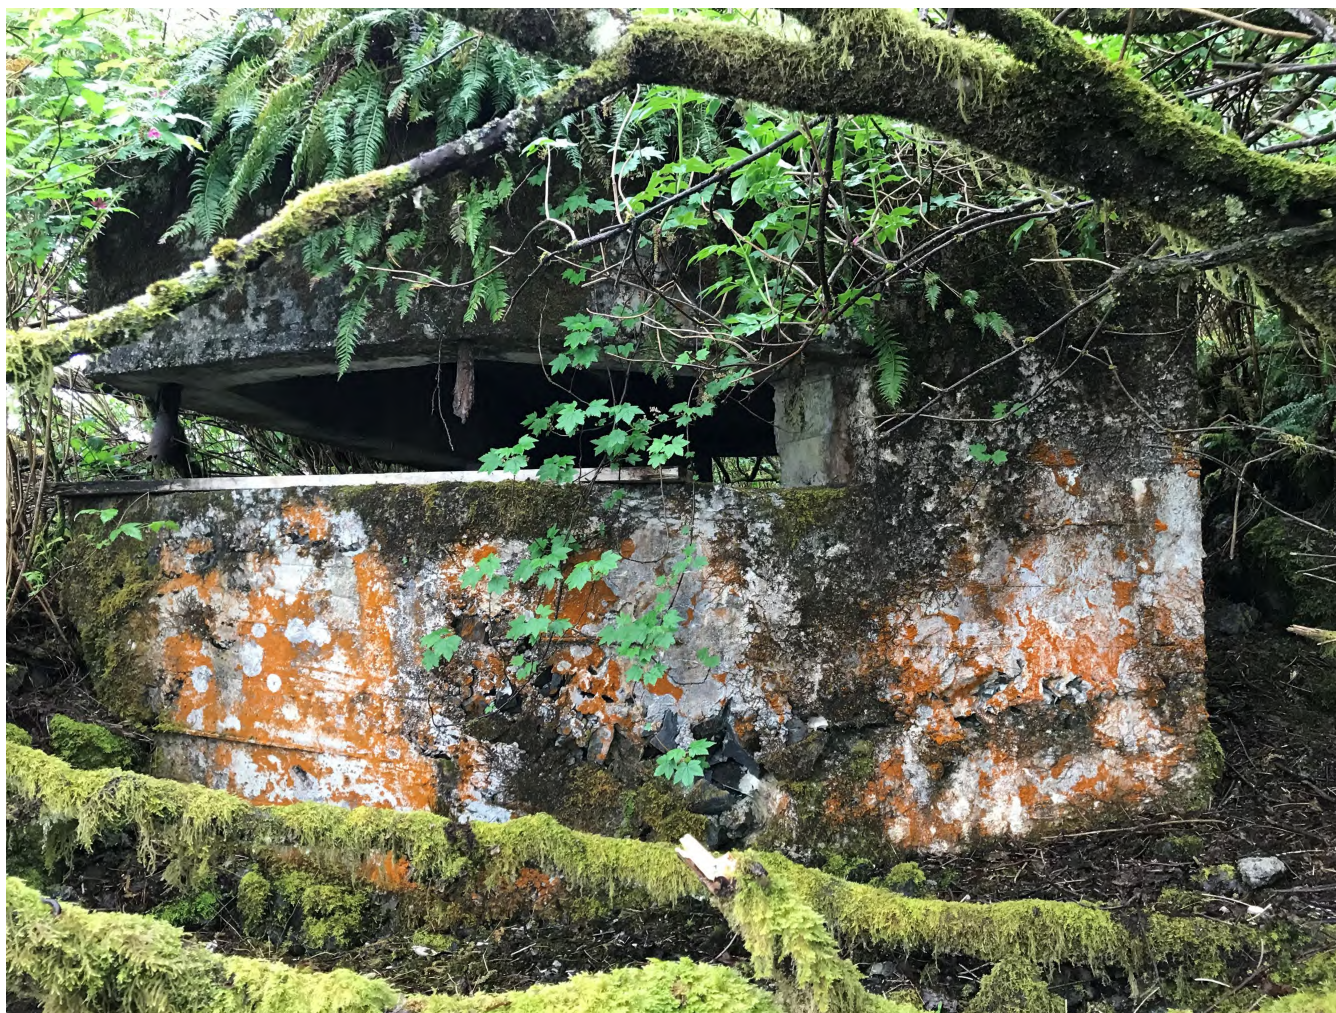
Light Spalling on NW Exterior Wall

The exterior of the building is slightly discolored and heavily overgrown with vegetation. The vegetation, which would have been entirely or partially cleared during use, has become overgrown, obscuring the seaward view. The building also shows some signs of spalling on the northwest side, possibly a result of deflection, or weakness caused by erosion (Figure 10). Wooden boards set high on the interior walls, which may have been used to mount brackets for electrical wiring, show some moisture damage but are otherwise in fair condition. The concrete at the door and observation slit shows some deterioration, likely from erosion. The metal pipe supports for the observation slits are heavily corroded (in one case, entirely corroded), which has resulted in slight spalling of the surrounding concrete (Figure 11).

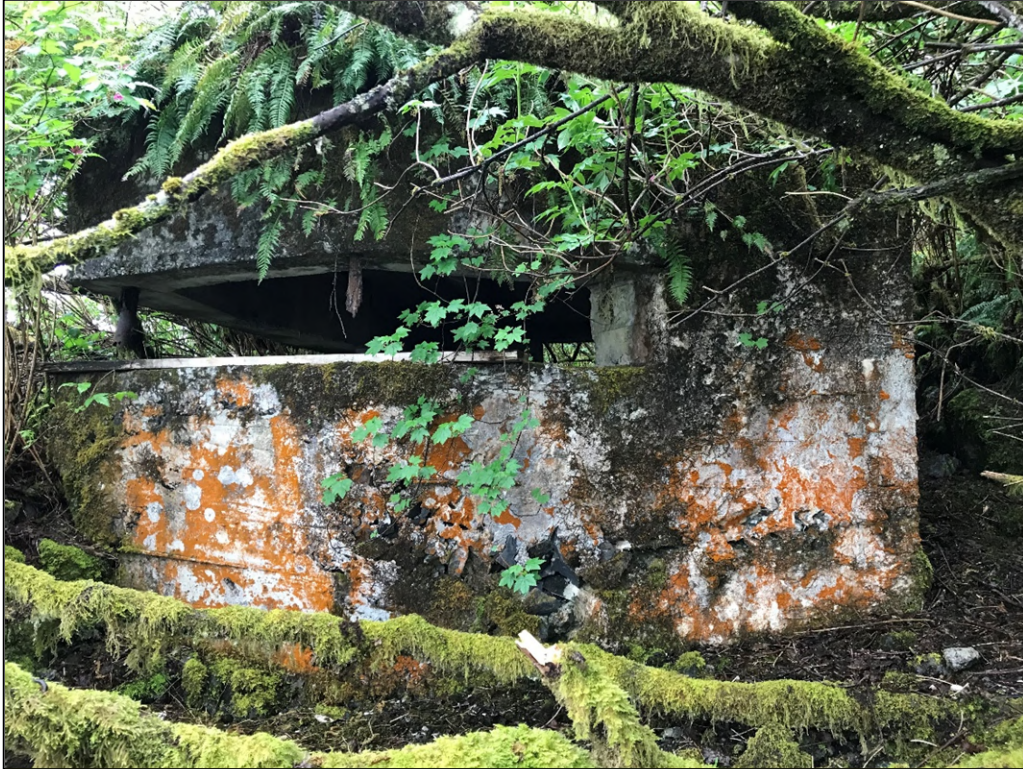
Photograph 1: Northwest Exterior of Observation Post (May 2020)

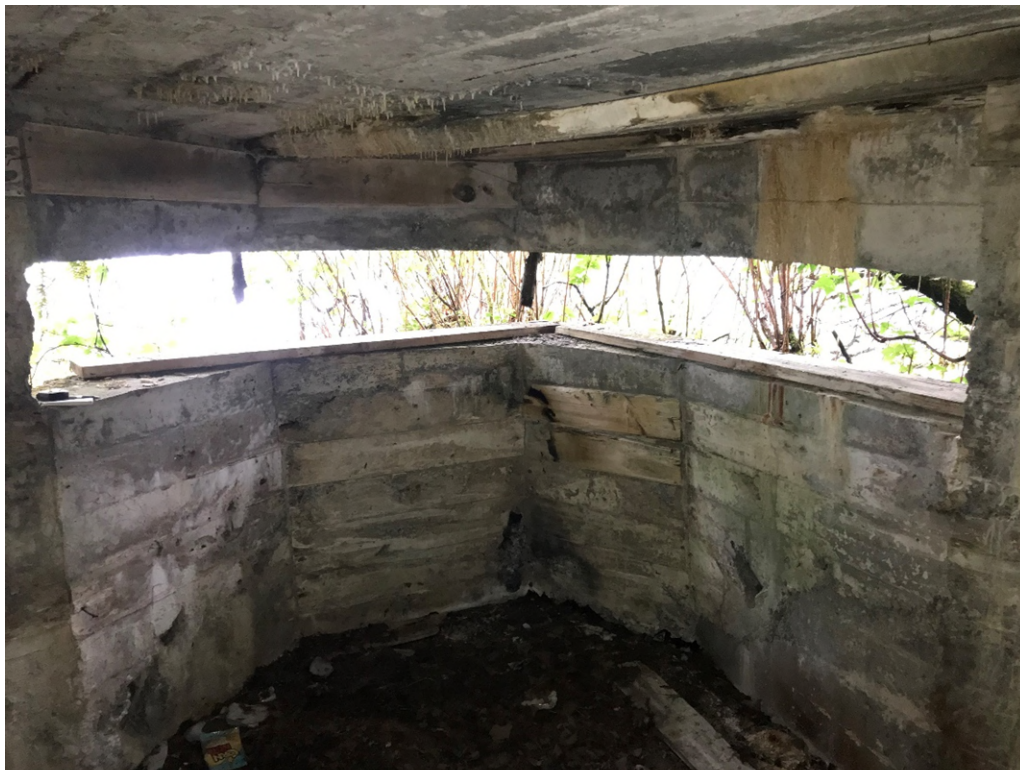
Photograph 2: Interior of Observation Post (May 2020)
