CITY AND BOROUGH OF SITKA New Sitka Seaplane Base

SITKA SEAPLANE BASE

Wetland Delineation/Functions and Values Report

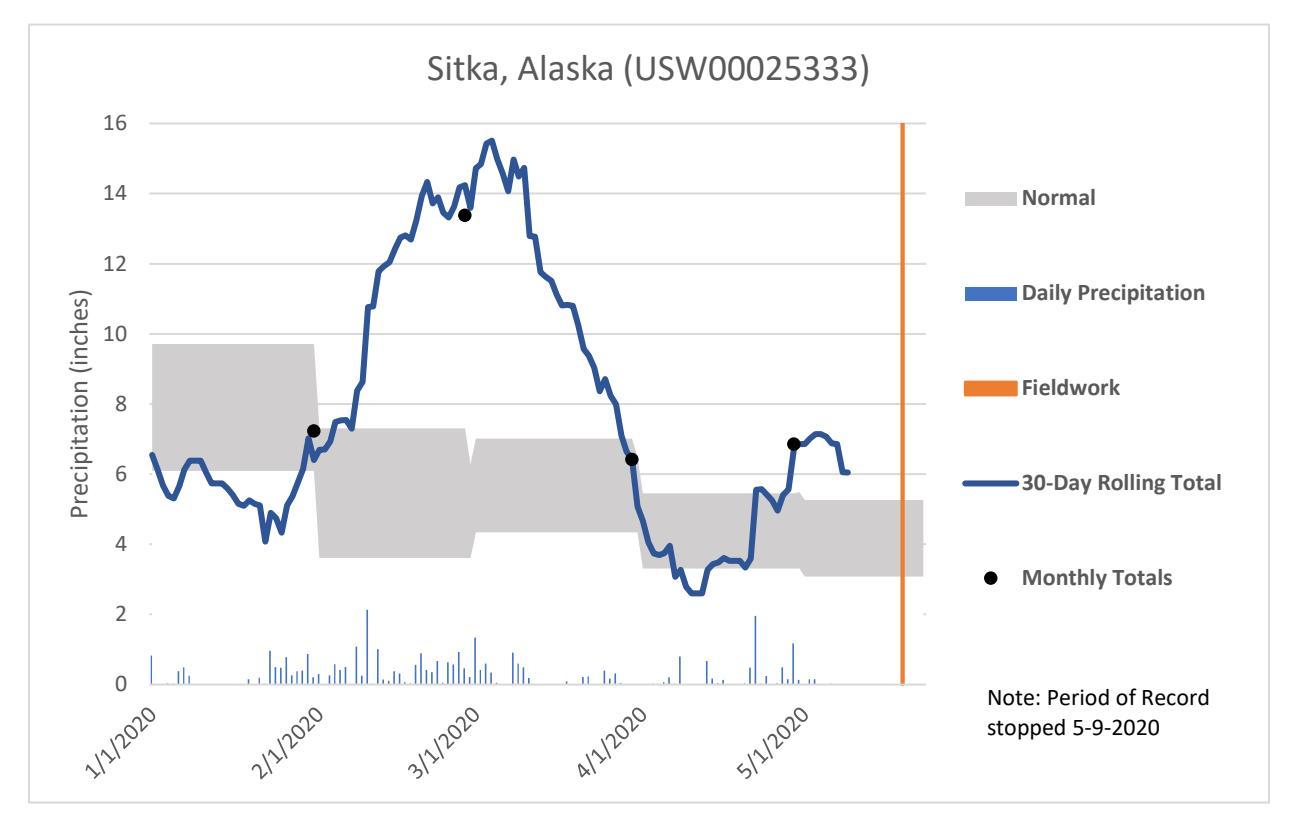
Graphic 1: Sitka Airport (USW00025333) 2020 Precipitation Data.

The closest global historical climatology network (GHCN) weather station is the Sitka Airport. The Sitka Airport GHCN weather station is located approximately 0.5 miles south of the project area. Precipitation data (Utah Climate Center 2020; Western Regional Climate Center 2020) from May 2000 to May 2020 was used to analyze antecedent conditions preceding the May 2020 data collection (Graphic 1). Daily precipitation values over a 30-day period were accumulated in order to examine the three-month period preceding data collection activities to determine if surface hydrology or soil moisture conditions observed were drier than normal, or wetter than normal (Natural Resource Conservation Service 2018). The period of record was stopped 5/9/2020 possibly due to COVID-19 impacts to data collection. Surface hydrology or soil moisture conditions to the precipitation analysis.

Using the NRCS method, it was determined that precipitation for the three months prior to the field investigation was above normal. Indicators of wetland hydrology were prevalent in the wetlands but lacking in upland areas.

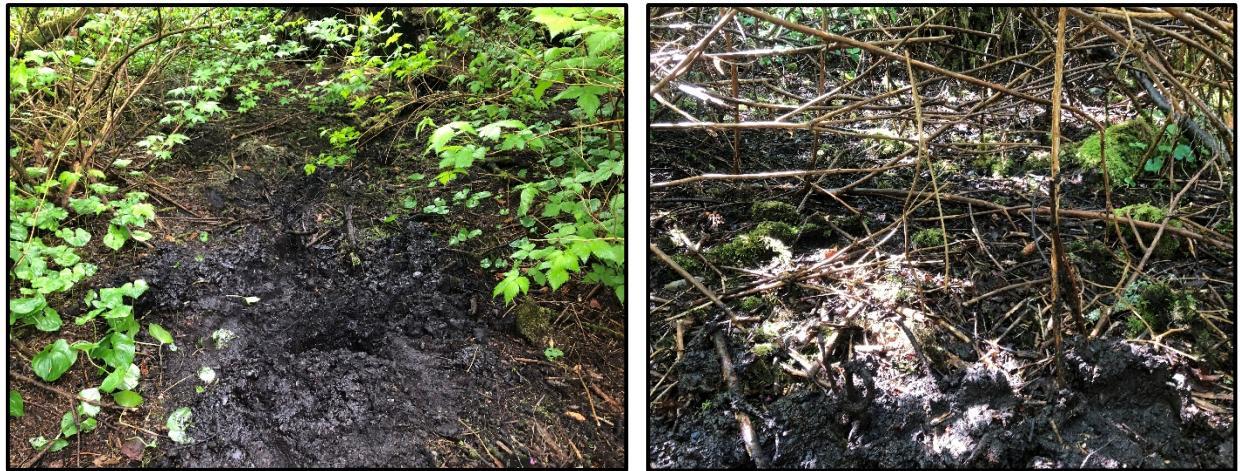
Photo Set 1: Typical Scrub-Shrub Wetland

Scrub-shrub wetlands (Cowardin classifications: PSS1B) are characterized by greater than 30% percent aerial cover in the shrub layer (Photo Set 1). These wetlands have a robust scrub shrub layer of stink currant (*Ribes bracteosum*) and salmonberry (*Rubus spectabilis*) with an herbaceous layer of false lily of the valley (*Maianthemum dilatatum*). All wetlands in the study area are classified as PSS1B. Characteristically, these wetlands are depressional, concave (two-to-three percent slopes) features that form as seeps.

The triangle-shaped seep wetland at TH 5 has problematic hydrophytic vegetation due to having a hydric soil, primary wetland hydrology, being a concave seep forming at a toeslope, and having a sparsely vegetated concave surface. The shrub stratum is growing over top of the wetland to maximize sunlight with few individuals rooted in the seep, and the herb stratum is growing at the downslope point of the triangle on a slight rise in elevation. The shrub stratum is dominantly salmonberry, which is most common on moist to wet, water-receiving sites in forested or wooded areas (Zouhar 2015). The Salmonberry aerial stems can be seen in Photo Set 1 on the right photo, growing laterally over top of the seep.

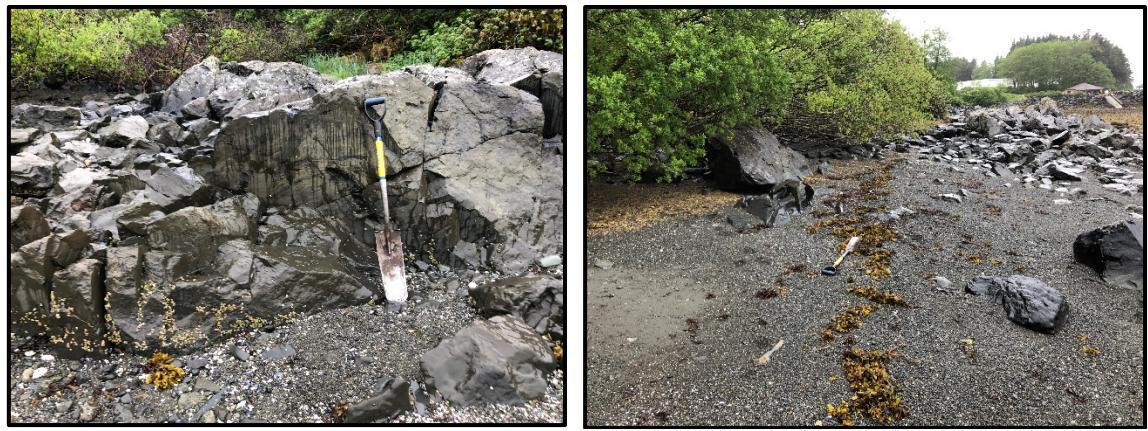
Photo Set 2: Mean High Water

Marine waters are found in tidal areas in Sitka Harbor below MHW. Waterbody consists of a tidally influenced coastline of Sitka Harbor. The MHW elevation of 9.16 feet was confirmed using a submeter accuracy GPS with visual observations of barnacles, saltwater vegetation growing on boulders, and debris deposits.

Marine waters below MHW are composed of gravel, cobble, boulder, and bedrock substrate with barnacles and marine vegetation growing along the rocks. A low tide survey was conducted with photos for various substrate types and is attached as Appendix C. Table 6 is a summary of marine waterbody data collected.
